Atlas Property Inspections, LLC

Property Inspection Report

Property address: **412 Elmwood Street
Suburbantown, NJ 08992**

Inspection date: **Monday, April 23, 2012**

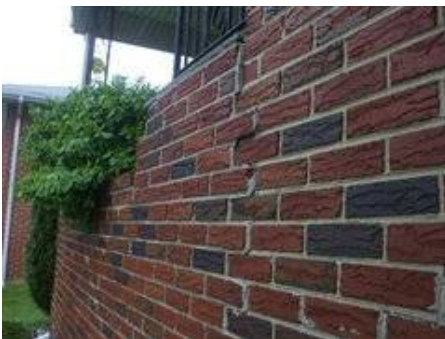
Photo 4-1

Cracks, deterioration, leaning and/or bowing were found in one or more retaining walls. Because of the height or proximity to foundations or property lines, a qualified structural engineer should evaluate to determine what repairs are necessary. Repairs should be made by a qualified contractor.

There are cracks and shifting of the wall on the rear retaining wall.

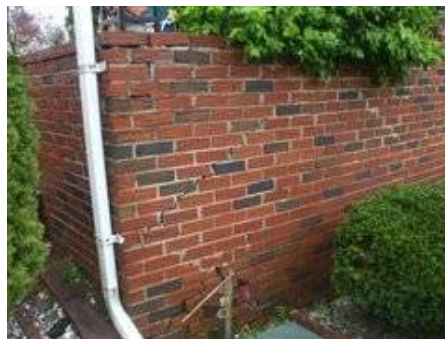
Photo 4-2

The rear retaining wall is showing cracks, bowing and settlement.

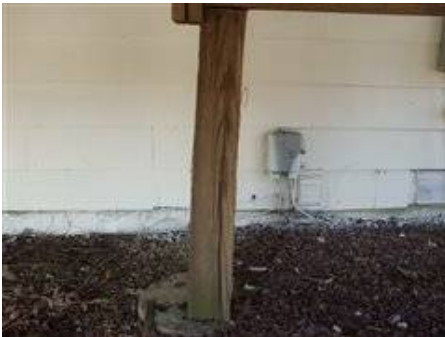
Photo 5-1

The support structure on the underside of the deck appears sub-standard. The support posts are out of plumb and are resting on concrete paver stones with no visible footing beneath. Attached deck structures should rest on footings that extend below the frost line. Structures that rest on the soil grade are prone to uneven settlement and frost heave. This can cause the structure to settle out of level. A licensed and qualified contractor should evaluate the deck structure and make repairs/replace as necessary.

The support posts below the deck are out of level and resting on concrete pavers on the ground with no visible footing beneath.

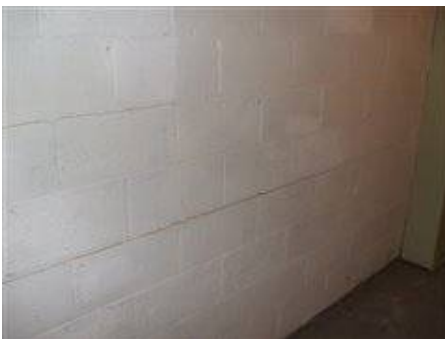
Photo 6-1

One or more major cracks (more than 3/4 inch wide) were found in the foundation. These appear to be a structural concern, and may indicate that settlement is ongoing. The client(s) are strongly advised to hire qualified contractors and/or engineers as necessary for further evaluation. Such contractors may include:

There is a long horizontal crack and visible bowing along the rear concrete block foundation wall.

- Foundation repair contractors who may prescribe repairs, and will give cost estimates for prescribed repairs
- Masonry contractors who repair and/or replace brick veneer
- Geotechnical engineers who attempt to determine if settlement is ongoing, and what the cause of the settlement is
- Structural engineers who determine if repairs are necessary, and prescribe those repairs

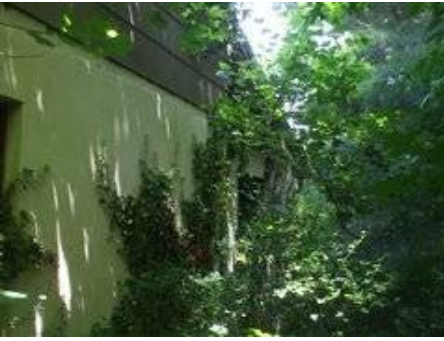
**Photo 7-1**

Vegetation such as trees, shrubs and/or vines are in contact with or less than one foot from the structure's exterior. Vegetation can serve as a conduit for wood destroying insects and may retain moisture against the exterior after it rains. Vegetation should be pruned and/or removed as necessary to maintain a one foot clearance between it and the structure's exterior.

There is vegetation growing against the East side of the structure.

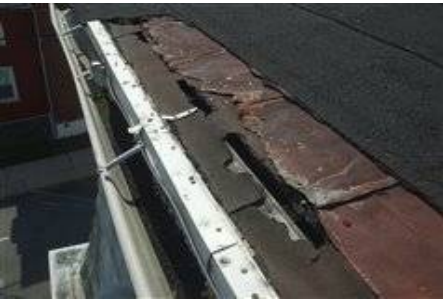
**Photo 8-1**

One or more areas of composition shingles are damaged, deteriorated and/or missing, and should be replaced. An area of asphalt shingles and sheathing are significantly deteriorated with the attic structure left exposed to the weather and rain water intrusion. A qualified roofing contractor should evaluate and make repairs as soon as possible, prior to closing.

The roof surface and sheathing are significantly deteriorated along the rear of the second floor.

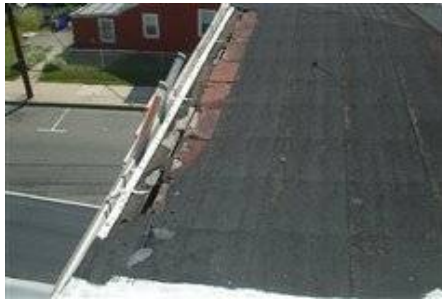
**Photo 8-2**

The roof surface and sheathing are significantly deteriorated along the rear of the second floor.

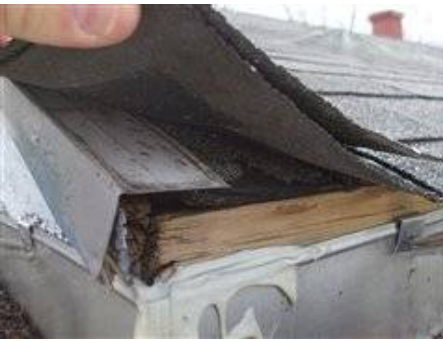
**Photo 9-1**

This asphalt or fiberglass composition roof surface has two or more layers of roofing materials. When this roof is replaced, recommend a complete "tear off", where all existing layers of roofing are removed before installing new roofing materials. For 20-year rated composition shingles, additional layers of material reduce the new roof material's lifespan as follows:

There are two layers of shingles on the roof.

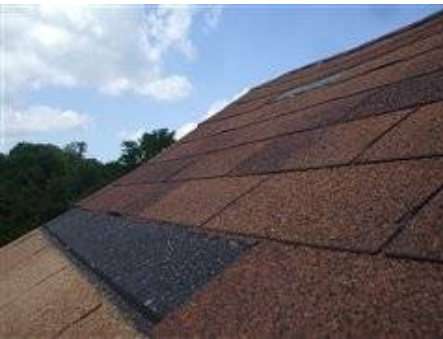
**Photo 10-1**

One or more composition shingles are damaged, deteriorated and/or missing, and should be replaced. Leaks may occur as a result. A qualified roofing contractor should evaluate and make repairs as necessary.

There are several missing shingles noted on the front gable of the roof.

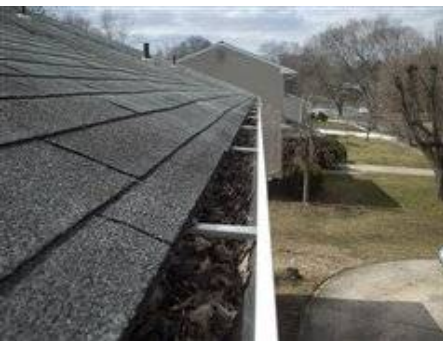
**Photo 11-1**

Debris has accumulated in one or more gutters. This is a conducive condition for wood destroying insects since gutters may overflow and cause water to come in contact with the structure's exterior or make water accumulate around the foundation. Gutters should be cleaned now and as necessary in the future.

The gutters along the front of the structure are clogged with leaves and debris.

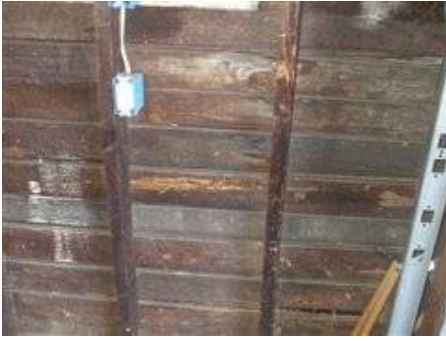
Photo 12-1

There is visible evidence of termite activity on the interior wall sheathing and wall structure in the detached garage. There is also evidence of moisture intrusion which may be leading to the activity. A licensed and qualified exterminator should

There is termite damage on the interior wall sheathing in the detached garage.

treat the area for termites as necessary. Also, a licensed and qualified contractor should evaluate the area and make repairs/replace the damaged wood as necessary.

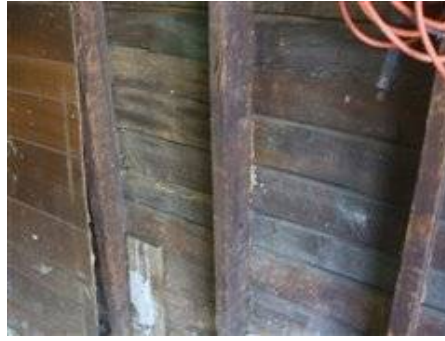
Photo 12-2

There is termite damage on the interior wall sheathing in the detached garage.

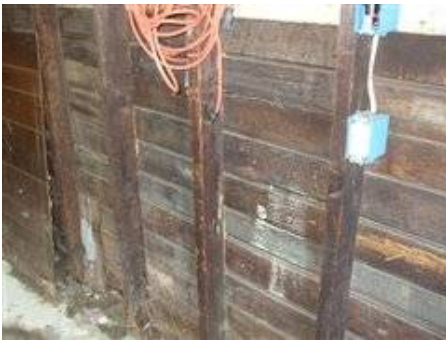
Photo 12-3

There is termite damage on the interior wall sheathing in the detached garage.

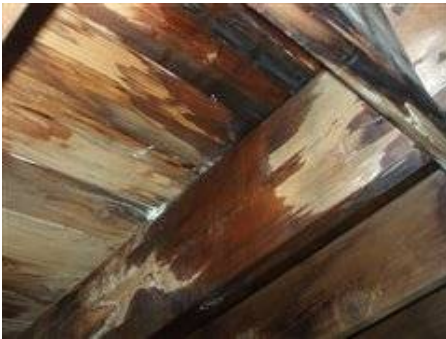
Photo 13-1

One or more areas of the roof structure were wet or had elevated levels of moisture at the time of the inspection. There appears to be an active leak in the roof or structure exterior. A qualified contractor should evaluate and repair as necessary.

There are active leaks around the chimney in the attic.

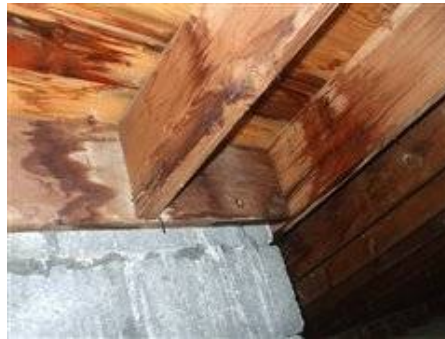
Photo 13-2

There are active leaks around the chimney in the attic.

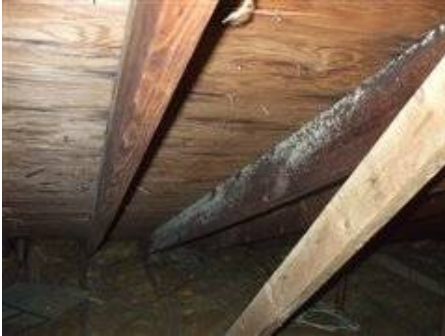
Photo 14-1

Ventilation is substandard in the attic. Inadequate attic ventilation may result in high attic and roof surface temperatures, reduce the life of the roof covering materials and increase cooling costs. High levels of moisture are also likely, and can be a conducive condition for wood destroying insects and organisms. Standard building practices require one square foot of vent area for 150 to 200 square feet of attic space. Vents should be evenly distributed between soffits, ridges and at corners to promote air circulation. A qualified contractor should evaluate and install vents as per standard building practices.

There is mold growth along the rafters and sheathing on the Northern side of the attic.

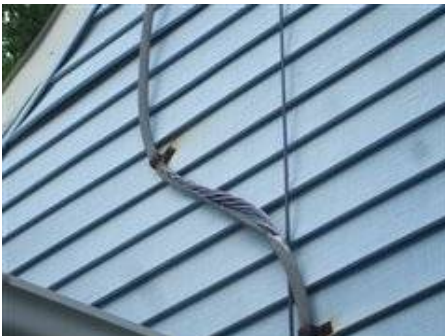
Photo 16-1

The service entrance wire insulation is frayed and/or deteriorated in one or more areas. A qualified electrician should evaluate and make repairs or replace wires as necessary.

The insulation on the service entrance wires is deteriorated.

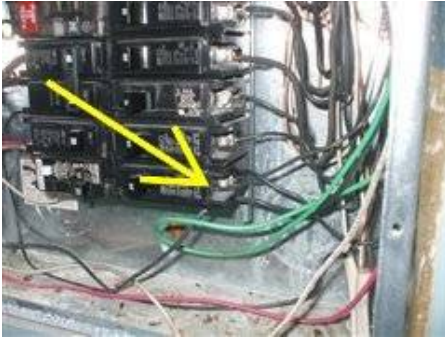
Photo 17-1

One or more overcurrent protection devices (circuit breakers or fuses) are "double tapped", where 2 or more wires are clamped in a terminal designed for only one wire. This is a safety hazard since the bolt or screw may tighten securely against one wire, but leave others loose. Arcing, sparks and fires may result. A qualified electrician should evaluate and repair as necessary.

There is a double tapped breaker in the service panel.

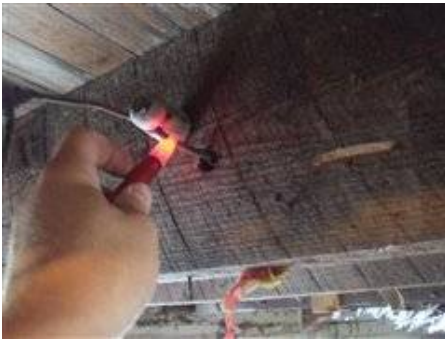
Photo 18-1

This property has "knob and tube" wiring, which was commonly installed prior to 1950. It is ungrounded, and considered unsafe by today's standards. Over time, the wire's insulation may become brittle and fall apart or wear thin, resulting in exposed conductors and a risk of shock and/or fire. This wiring is also easily damaged by covering it with insulation (a common practice), and incorrectly tapping new wiring into it.

Some energized knob and tube wiring was found during the inspection. It is not within the scope of this inspection to determine what percentage of this property's wiring is of the knob and tube type, or to determine what percentage of the knob and tube wiring is energized vs. abandoned. A qualified electrician should evaluate this wiring and make repairs or replace wiring as necessary.

There is active knob and tube wiring in the basement.

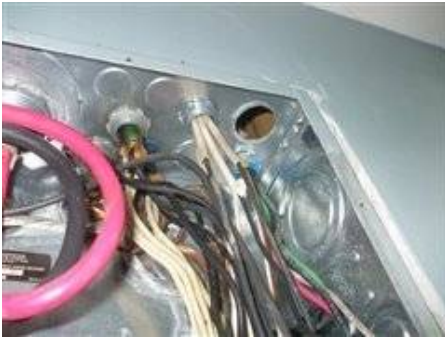
Photo 19-1

One or more knockouts have been removed inside the main service panel where no wires and bushings are installed, and no cover(s) have been installed to seal the hole(s). This is a safety hazard due to the risk of fire. A qualified electrician should install knockout covers where missing.

There is an open knockout in the top of the service panel.

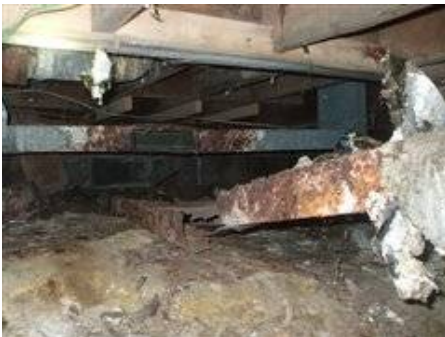
Photo 21-1

One or more air supply ducts are broken or disconnected. Increased moisture levels in unconditioned spaces and higher energy costs may result. A qualified contractor should evaluate and make permanent repairs as necessary.

One of the ducts in the crawlspace is rusted and disconnected.

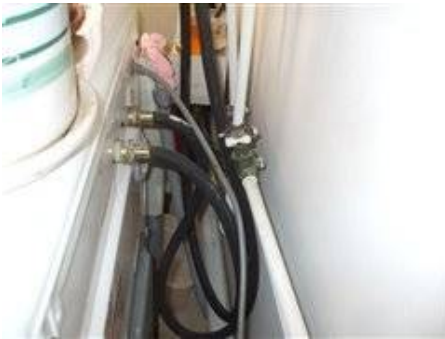
Photo 23-1

- 23) 📌💧 The clothes washer utilizes rubber water supply lines. These rubber hoses are known to become brittle with age and can be at risk of bursting. A burst hose can flood the home with full public water pressure. I recommend replacing the water supply hoses with braided stainless steel burst-resistant hoses.

The washing machine uses rubber water supply hoses.

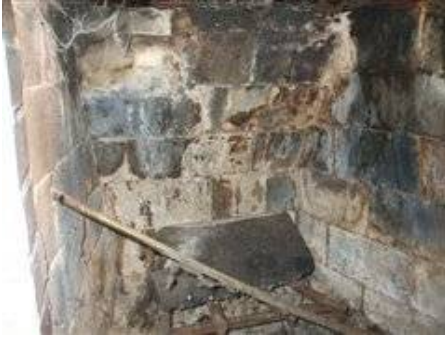
Photo 25-1

- 25) 🚨🔧🔍 Fire bricks in one or more fireplace fireboxes are loose and/or significantly deteriorated or pitted. This is a fire hazard. A

There is significant deterioration to the firebrick and mortar joints in the firebox from water intrusion.

qualified chimney service contractor should evaluate and repair as necessary.

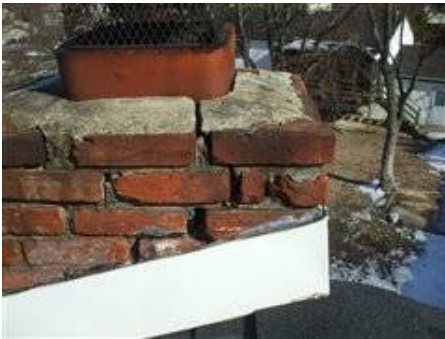
Photo 26-1

The masonry chimney's mortar is deteriorated and should be repaired to prevent further, significant deterioration. Recommend having a qualified chimney service contractor or mason evaluate chimney and repair as necessary. This will likely require repointing the mortar.

The bricks and mortar joints at the chimney cap are showing significant deterioration.

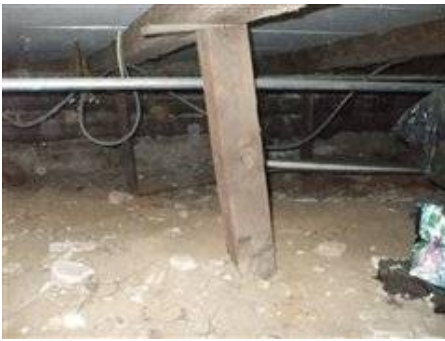
**Photo 28-1**

There are temporary support posts installed in the crawlspace that have not been tied into the floor structure and are resting on the soil. Also, the post has settled out of plumb and is no longer adequately supporting the load above. This can to possible sagging of the floor above. Also, the wood in contact with the ground can attract wood destroying insects. A licensed and qualified structural contractor should evaluate the area and make repairs as necessary.

There are out of level temporary wood support posts in the crawlspace in the front of the basement.

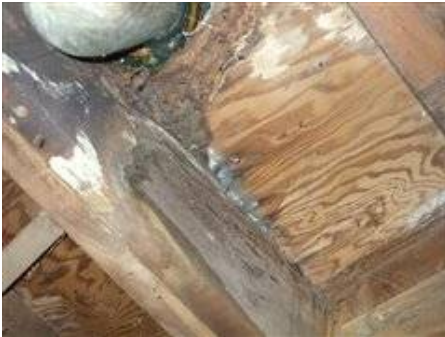
**Photo 29-1**

There is visible evidence of active plumbing leaks and deterioration to the subfloor below the bathroom and laundry room. The wood subfloor is wet and showing rot. This can lead to structural deficiencies to the floor and can also lead to mold and can attract wood destroying insects. A licensed and qualified plumbing contractor should evaluate the areas and make repairs as necessary including replacing any deteriorated subfloor and structure.

There is visible moisture damage to the subfloor below the first floor bathroom.

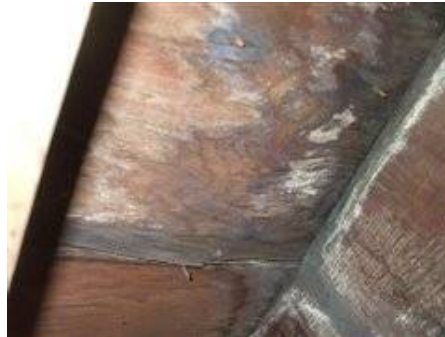
**Photo 29-2**

There is visible moisture damage to the subfloor in the crawlspace below the laundry room.

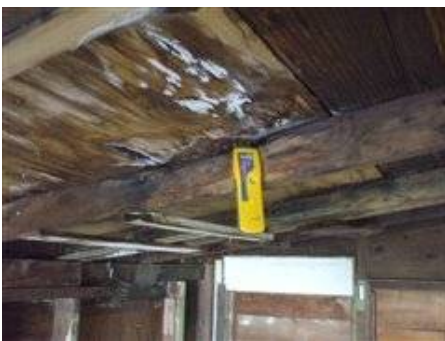
**Photo 29-3**

There is an active roof leak in the shed roof on the side of the garage.

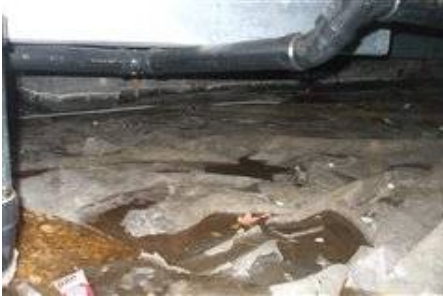
Photo 30-1

Standing water was found in one or more sections of the crawl space. Accumulated water is a conducive condition for wood destroying insects and organisms and should not be present in the crawl space. A qualified contractor who specializes in drainage issues should evaluate and repair as necessary. Typical repairs for preventing water from accumulating in crawl spaces include:

There is standing water in the crawlspace.

- Repairing, installing or improving rain run-off systems (gutters, downspouts and extensions or drain lines)

- Improving perimeter grading
- Repairing, installing or improving underground footing and/or curtain drains

Ideally, water should not enter crawl spaces, but if water must be controlled after it enters the crawl space, then typical repairs include installing trenches, drains and/or sump pump(s) in the crawl space.

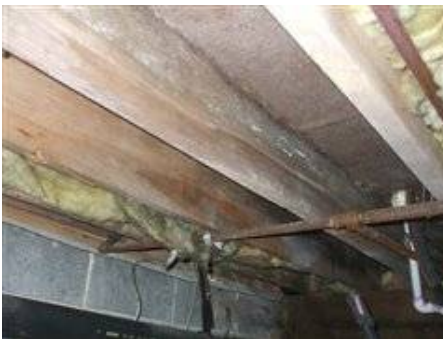
Photo 31-1

No insulation under floor in crawl space in some areas. Recommend that a qualified contractor install R19 or better (6" thick fiberglass batt) insulation below floor where missing for energy efficiency.

There are areas of missing insulation under the floor in the crawlspace.

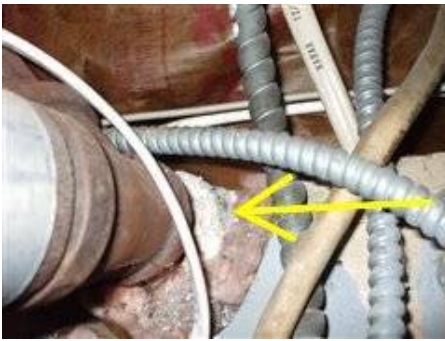
Photo 33-1

What appears to be asbestos is visible on some plumbing pipes in the basement. It is significantly deteriorated in some areas, and if it is asbestos, it may pose a health hazard and require abatement. I recommend having this material tested at a qualified lab. If the material is found to contain asbestos, recommend consulting with a qualified asbestos abatement contractor or industrial hygienist. For information on asbestos hazards in the home, visit:

There is what appears to be possible asbestos on the heating pipes where they enter the wall in the rear of the basement.

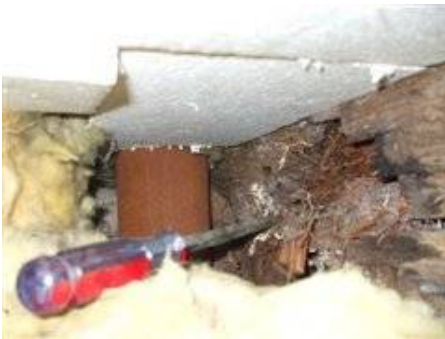
Photo 34-1

An area of the rim joist along the front of the basement is deteriorated from elevated moisture. This can compromise the structural support of the wall(s) above and can attract wood destroying insects. A licensed and qualified contractor should evaluate the area and make repairs/replace as necessary.

There is significant wood rot to the rim joist along the front of the crawlspace under the front porch.

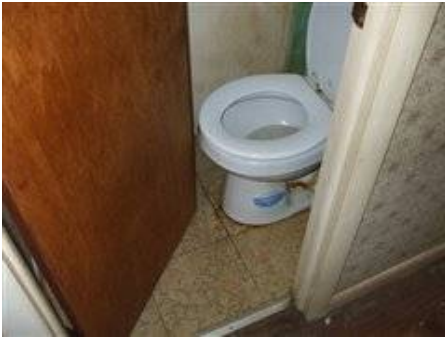
**Photo 36-1**

The door to the second floor bathroom does not close. The toilet is positioned so that it blocks the swing of the door. A licensed and qualified contractor should evaluate the issue and make repairs/replace as necessary.

The door in the second floor bathroom does not close.

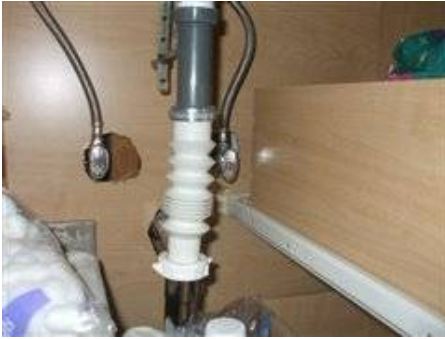
**Photo 37-1**

One or more sink drains use flexible drain pipe. This type of drain pipe is more likely to clog than smooth wall pipe. Recommend having a qualified plumber replace this pipe with standard plumbing components (smooth wall pipe) to prevent clogged drains.

The sink drain line in the hallway bathroom uses a section of flexible drain line.

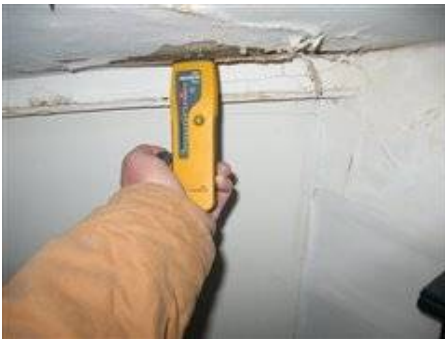
**Photo 38-1**

Stains and elevated levels of moisture were found in one or more ceiling areas. The stain(s) appear to be due to roof leaks. A qualified contractor should evaluate and repair as necessary.

There is an active roof leak in the rear bedroom ceiling.

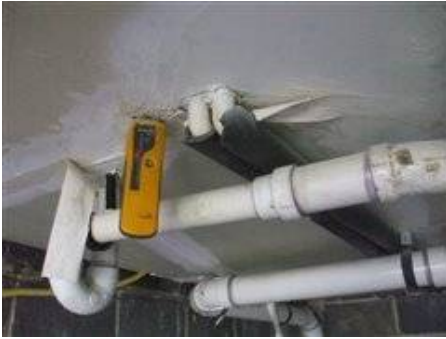
Photo 39-1

Stains and elevated levels of moisture were found in one or more ceiling areas. The stain(s) appear to be due to plumbing leaks. A qualified contractor should evaluate and repair as necessary.

There is an active leak under the kitchen sink.

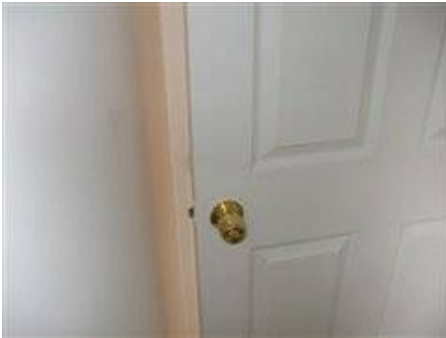
Photo 40-1

One or more doors will not latch when closed. Repairs should be made as necessary, and by a qualified contractor if necessary. For example, aligning strike plates with latch bolts and/or replacing locksets.

The front corner bedroom door does not latch when closed.

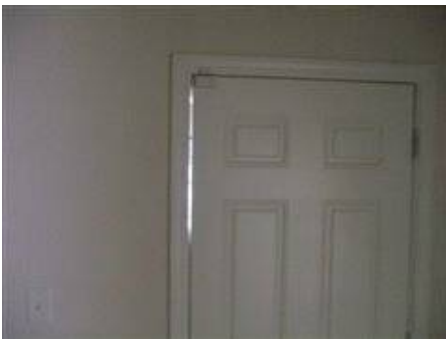
Photo 41-1

The weatherstrip around one or more exterior entry doors is missing and/or deteriorated. Weatherstrip should be installed where missing and/or replaced where deteriorated, and by a qualified contractor if necessary.

The side entry door has a gap in the weatherstripping.
