Atlas Property Inspections, LLC

Property Inspection Report

Property address: **412 Elmwood Street
Suburbantown, NJ 08992**

Inspection date: **Monday, April 23, 2012**

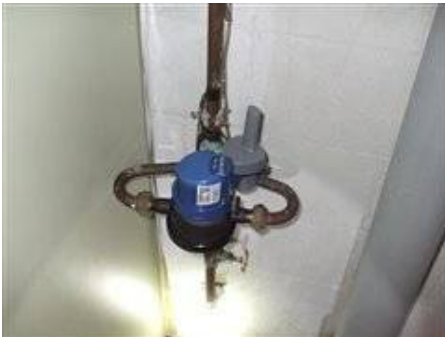
Photo 24-1

- 24) 📌 The main shutoff for the water service is located in the front of the basement. This valve should be used to shut off the water supply to the house in the event of a plumbing emergency such as a burst pipe, etc.

The water meter and main shutoff are located in the front corner of the basement.

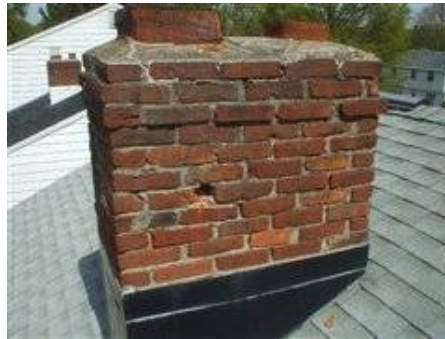
Photo 26-2

The bricks and mortar joints at the chimney cap are showing significant deterioration.
